Mitigating Murphy's Law While Test

Case study

- **Origin:** this study shares what has been seen and experienced onsite from us
- **Target:** provide important insight and illuminate previously hidden issues
- **Systematic approach:** each case is studied with the mention of the fault, the cause of the fault, the consequence and the solution.

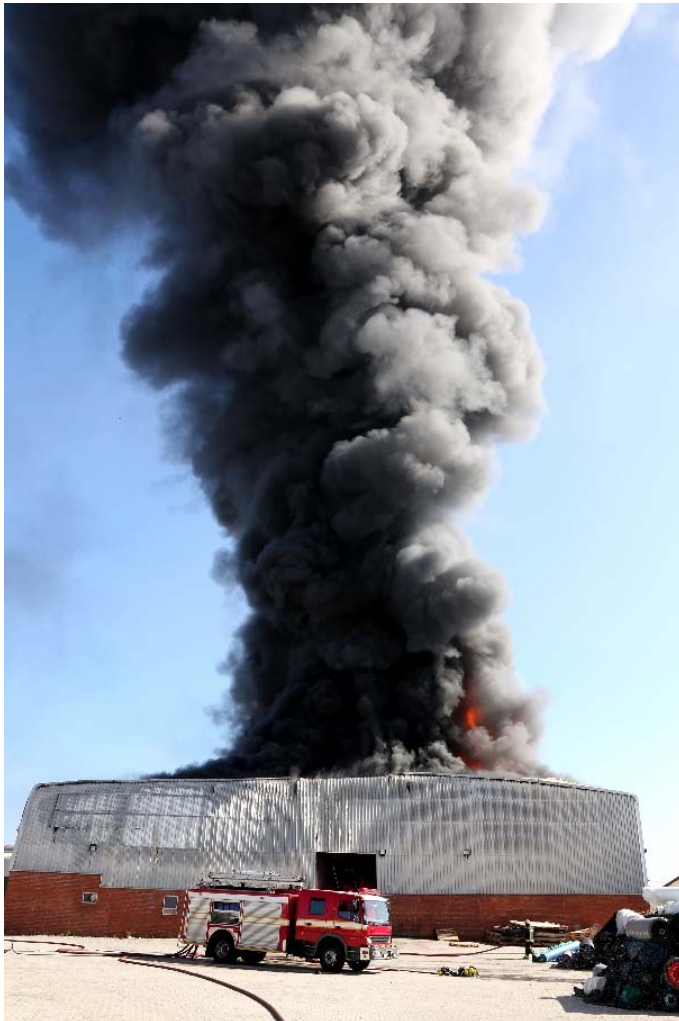
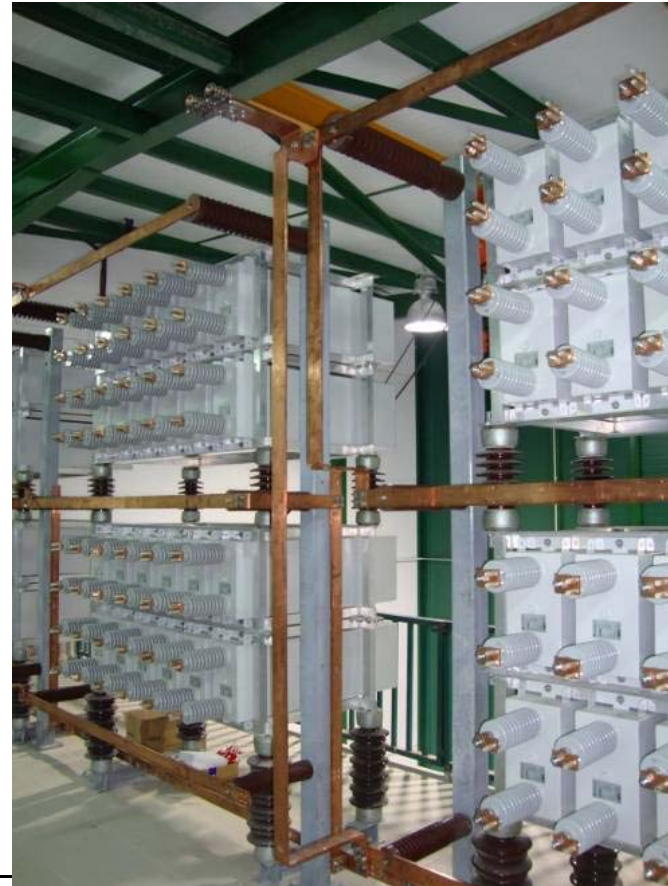
C-Bank was in the test circuit
during the induced voltage test

72 kV / 200 Hz applied on
a 20 kV 60 Hz C-Bank

- C-Bank fire is most of the time a dramatic situation, as the bank is installed inside the factory!

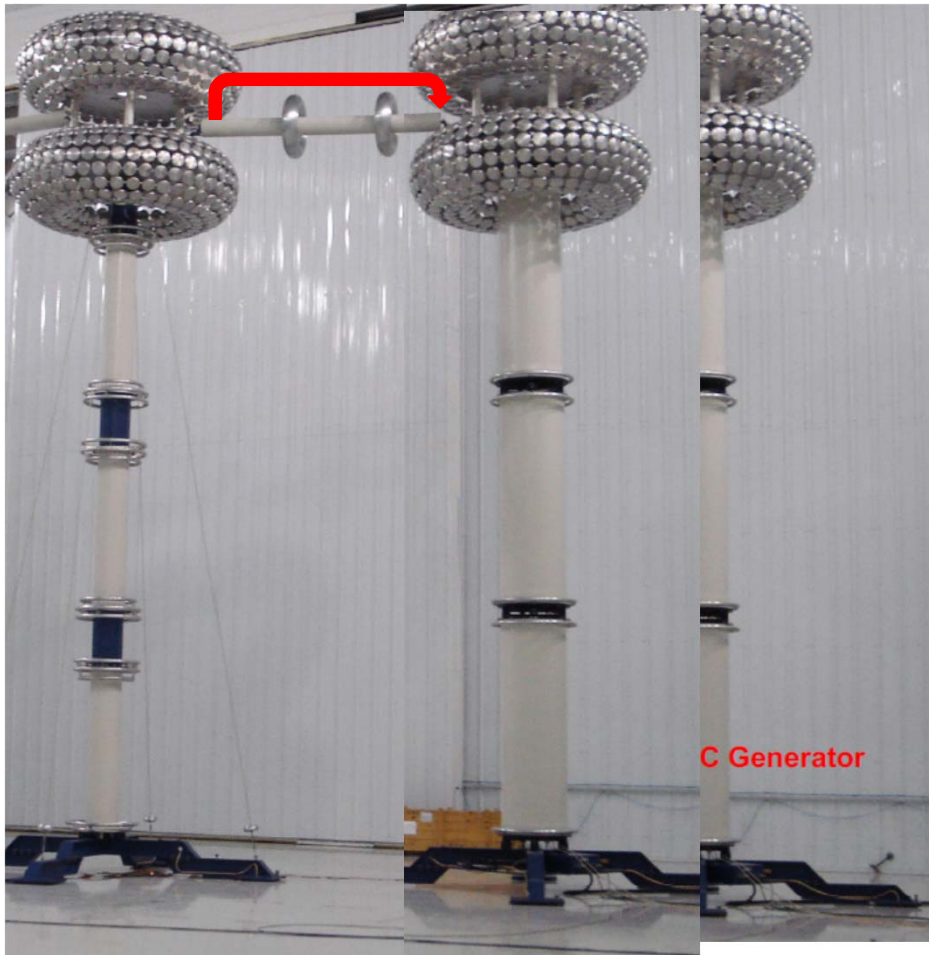
Customer replaced the damping resistance, which was wrongly designed

After cable break down, the flash went back to the DC generator, the damping resistance could not stop the high current and the DC generator breaks down

- Onsite test on a 35 km submarine cable
- The onsite test cabin was too small
- Customer decides to replace the damping resistor with a shorter damping resistor. (same resistance value!)
- DC hipot at 380 kV
- Breakdown of the cable
- Flash back with huge current to the damping resistor, the flash goes over the resistor and destroys the generator

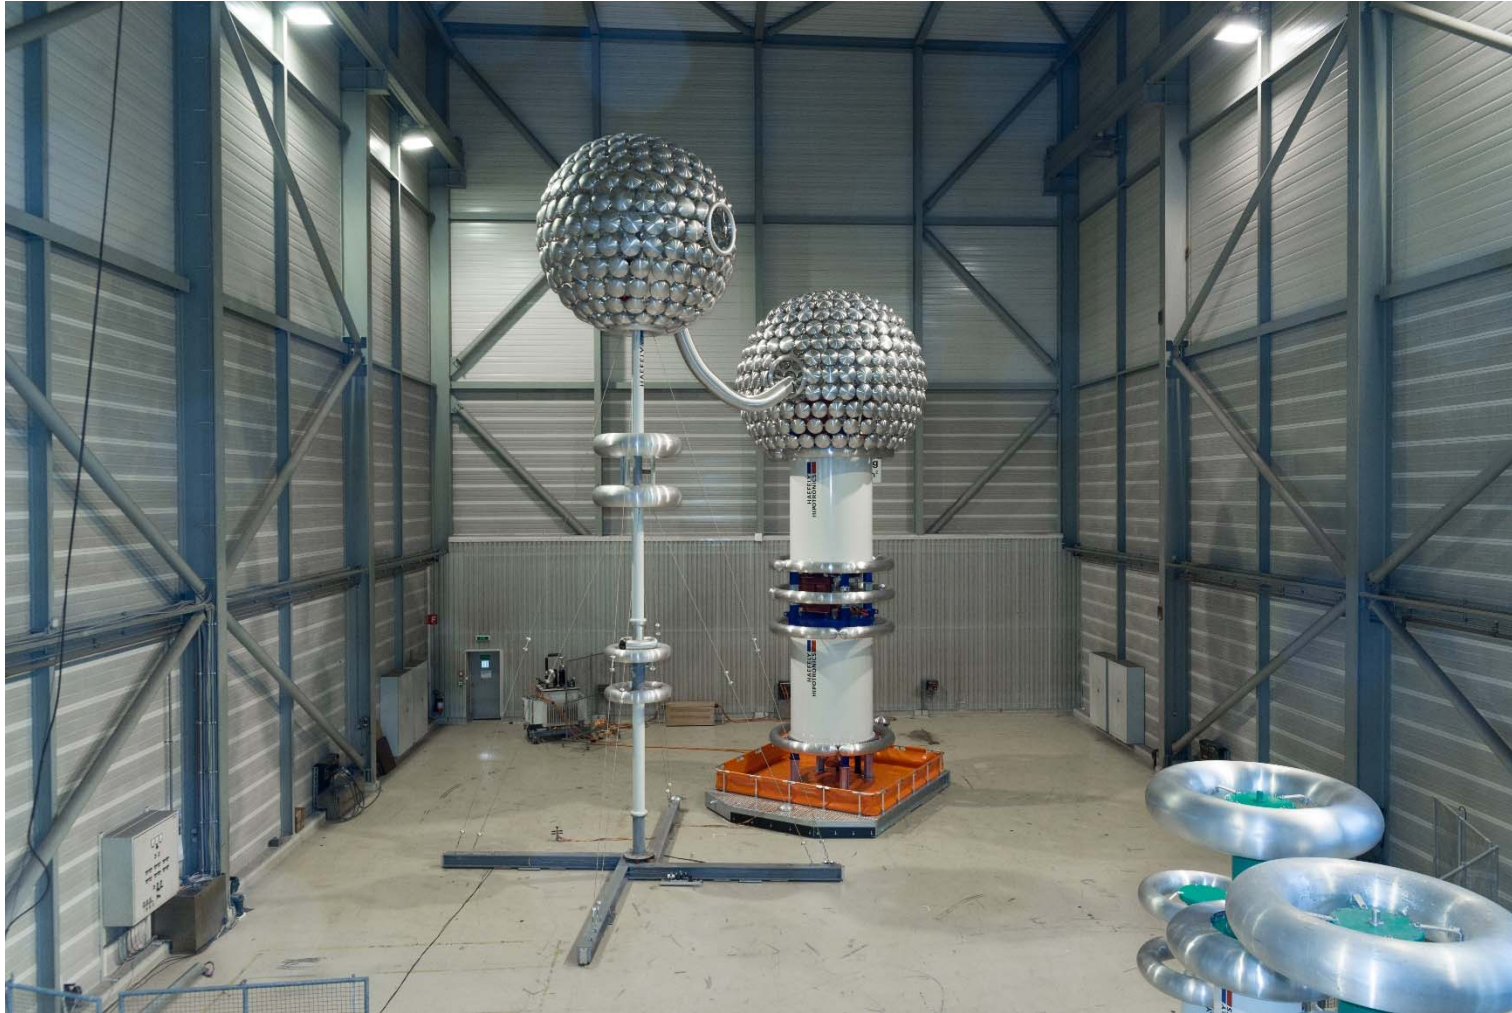
Case Study: PD 1

- Usual test setup: AC source + coupling capacitor + meas. Imp. + PD detector
- Test engineer has 2 PD detectors / measuring impedances (end user request)
- He changes the measuring impedance and forgets to ground it
- Coupling capacitor is floating
- Flash occurs while rising voltage
- After power off, the coupling cap. remains charged: dangerous situation

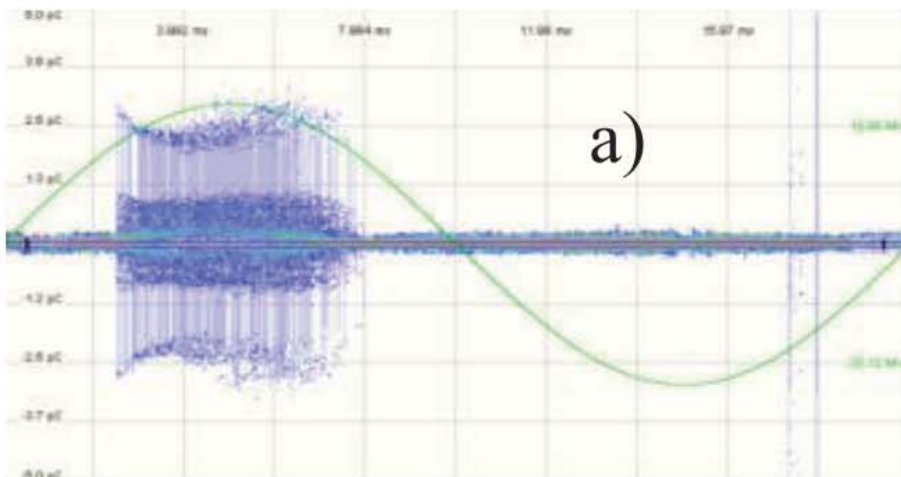
- Pulse polarity:
 - a) ambiguous recognition due to **fixed** dead time, wrongly set
 - b) distinct recognition without ambiguity, thanks to **dynamic** dead time (automatic)

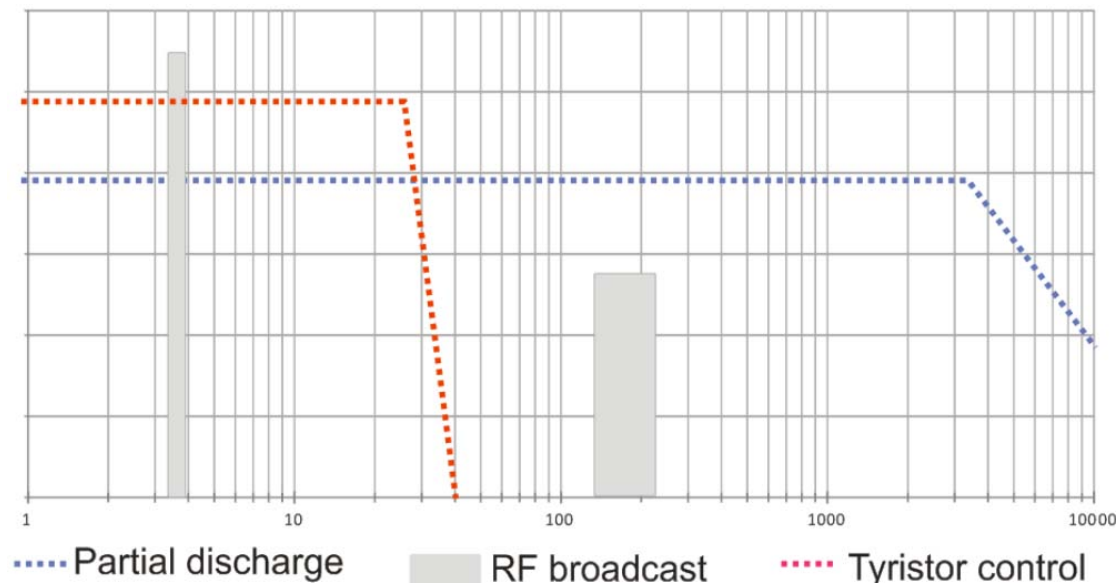
Measurement out of the IEC standard measurement band (higher frequency range)

- Wide-band PD instruments (chapter 4.3.4 in IEC 60270:2015)
 - $30 \text{ kHz} \leq f_1 \leq 100 \text{ kHz}$,
 - $f_2 \leq 1000 \text{ kHz}$
 - $100 \text{ kHz} \leq \Delta f \leq 900 \text{ kHz}$
 - PD pulse loses high frequency content while travelling thru transformer

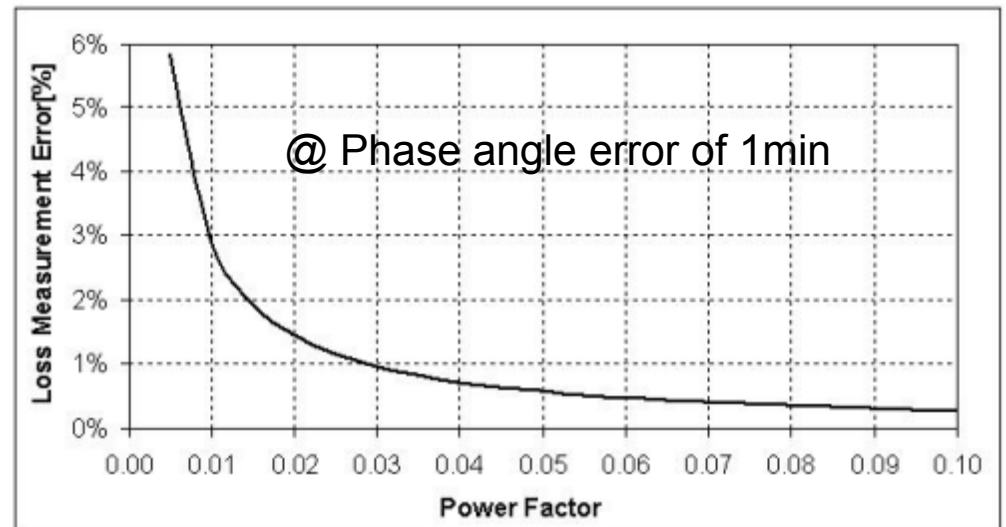
IEEE Std C57.123-2010 [4.3]

- Phase angle error of 1min in the voltage or current will result in approx. 3 % error in loss meas. for a power factor of 0.01
- **Load loss at low power factor are very sensitive to phase angle errors**

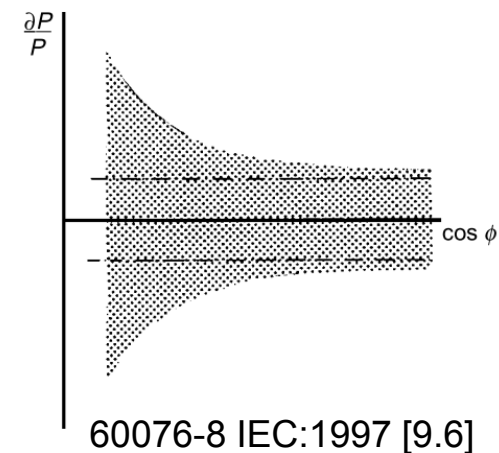
- During meas: the transformer behaves inductive
- Power factor tends to fall with rising values of rated power
 - Typical example:
 - **1'000 kVA** transformer: load loss 1 %, short circuit impedance 6 % of ref. impedance – power factor of the series impedance: **0.167**
 - **100 MVA transformer**: load loss 0.4 %, short circuit impedance 15 % of ref. impedance – power factor of the series impedance: **0.027**

$$\frac{\partial P}{P} = \frac{\partial U}{U} + \frac{\partial I}{I} - \frac{\sin \phi}{\cos \phi} \times \partial \phi$$

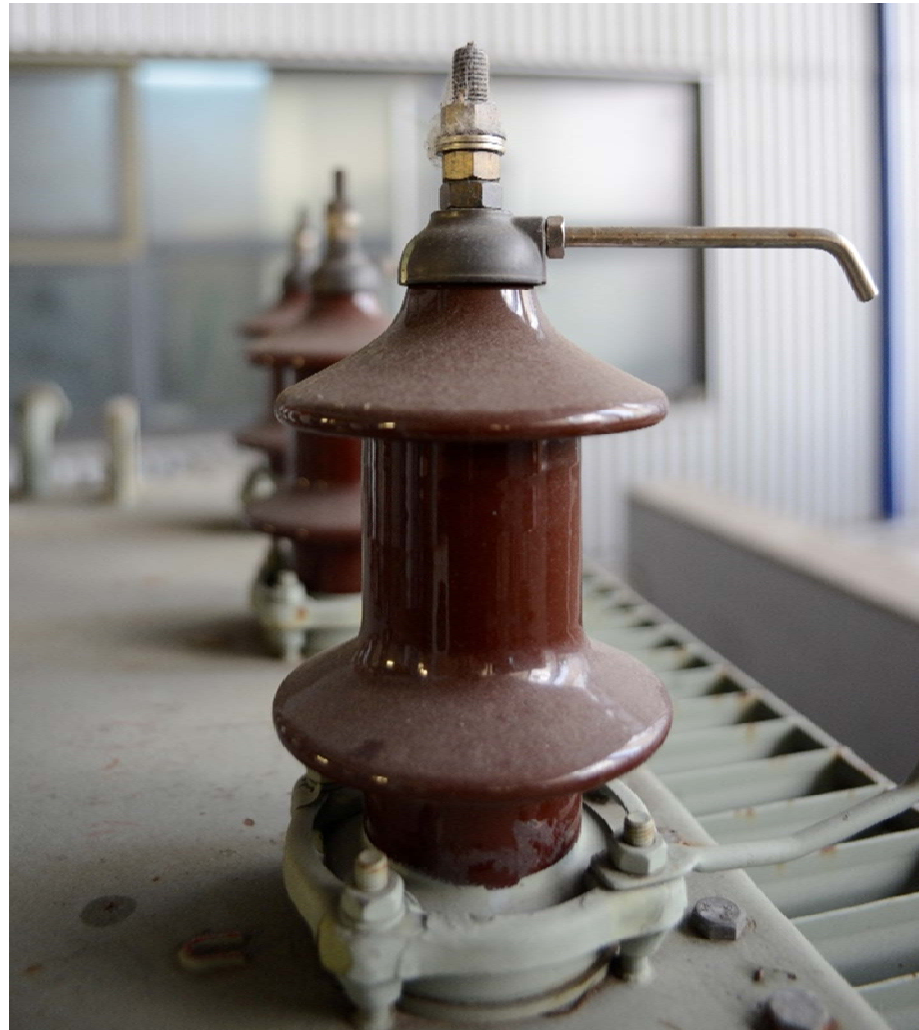
Dirty bushing

Leakage current increases the power factor

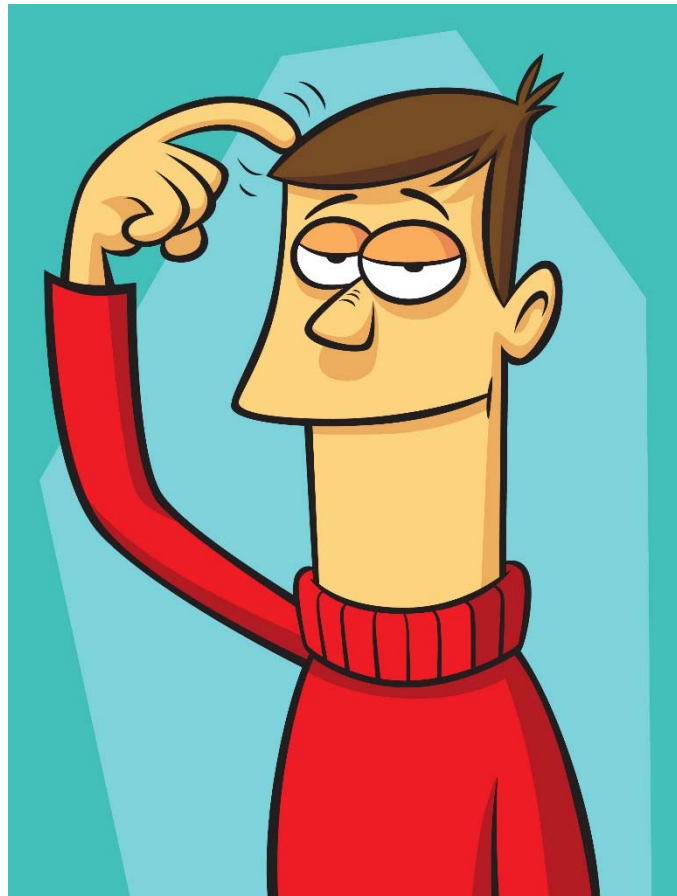
Anything that can go wrong will go wrong,

But all situations could have been avoided!!!!!!!

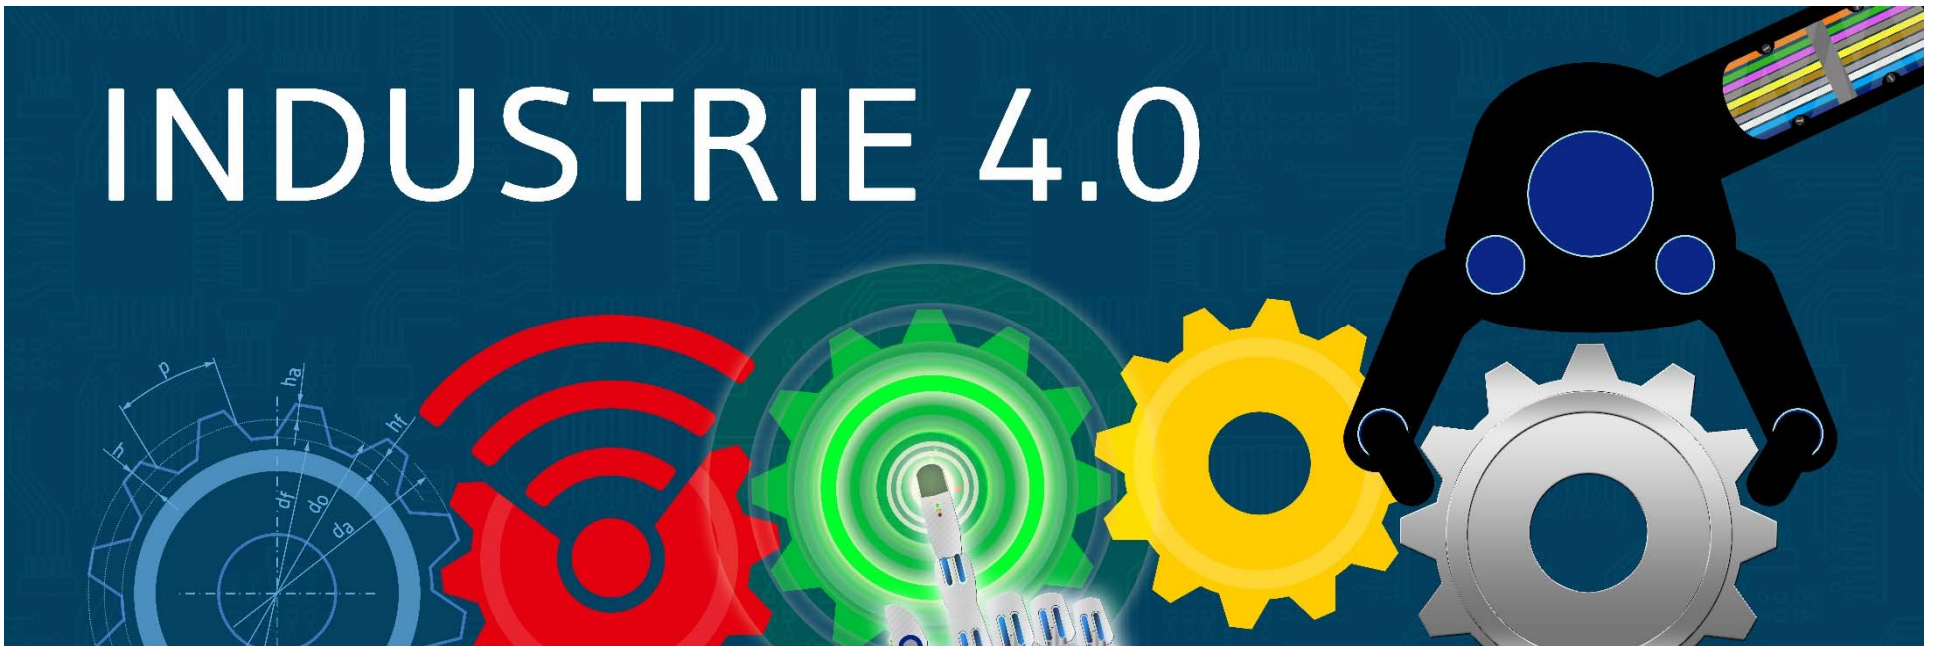
Technology level

- If a system is the cause of a fault, upgrading the system would be the solution

Better technology will avoid system failure!

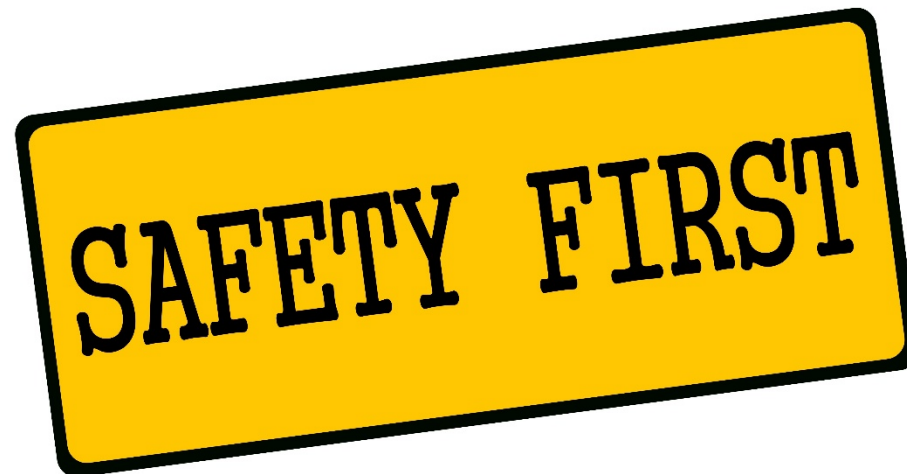
Safety

- Half of the dangerous situations are caused by the system technology. Upgrading the system would fix the problem.

Think safety first and if requested upgrade the system!

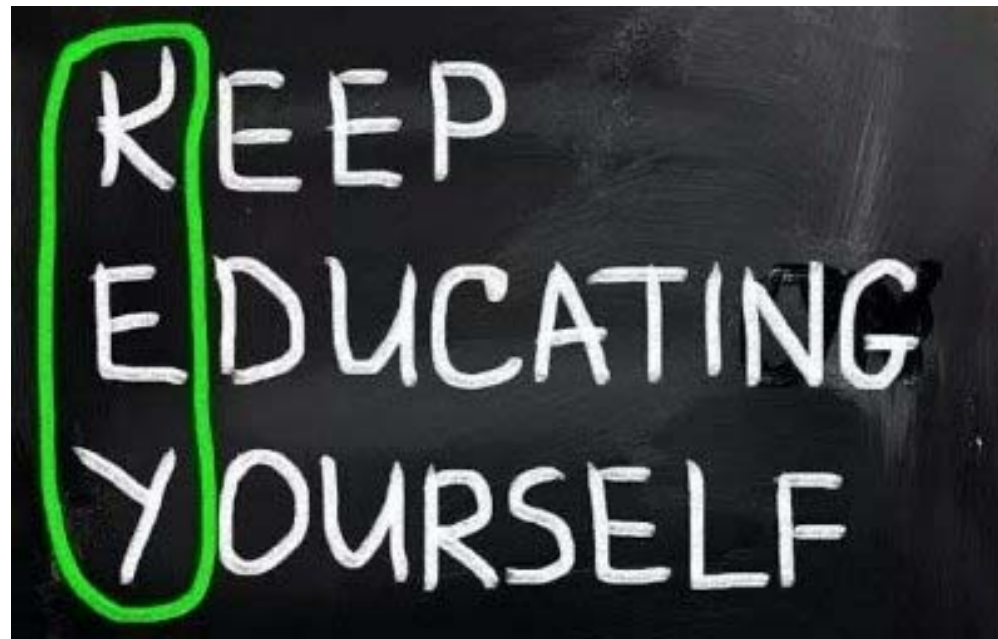
Knowledge

- Half of the problems are linked to operator knowledge. Read the user manual first and get trained!
